**DEPARTMENT OF TRANSPORTATION****DIVISION OF ENGINEERING SERVICES**

Contract #: 04-0120F4Cty: SF/ALA Rte: 80 PM: 13.2/13.9File #: 69.28**WELDING INSPECTION REPORT****Resident Engineer:** Pursell, Gary**Address:** 333 Burma Road**City:** Oakland, CA 94607**Report No:** WIR-006653**Date Inspected:** 07-May-2009**Project Name:** SAS Superstructure**OSM Arrival Time:** 700**Prime Contractor:** American Bridge/Fluor Enterprises, a JV**OSM Departure Time:** 1900**Contractor:** Zhenhua Port Machinery Company, Ltd (ZPMC), Changxing Island **Location:** Shanghai, China**CWI Name:** Chen Xi**CWI Present:** Yes No**Inspected CWI report:** Yes No N/A**Rod Oven in Use:** Yes No N/A**Electrode to specification:** Yes No N/A**Weld Procedures Followed:** Yes No N/A**Qualified Welders:** Yes No N/A**Verified Joint Fit-up:** Yes No N/A**Approved Drawings:** Yes No N/A**Approved WPS:** Yes No N/A**Delayed / Cancelled:** Yes No N/A**Bridge No:** 34-0006**Component:** OBG crossbeams**Summary of Items Observed:**

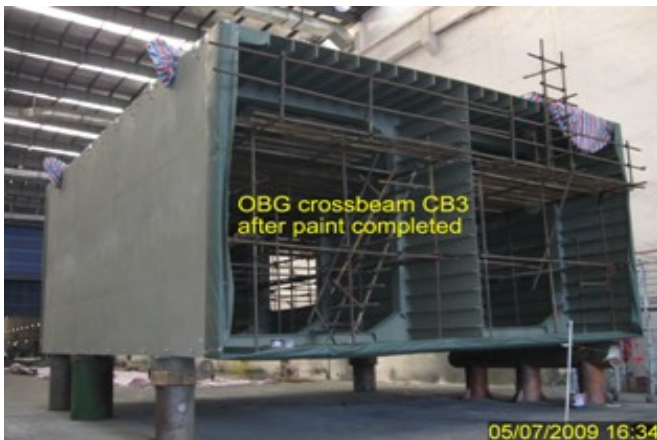
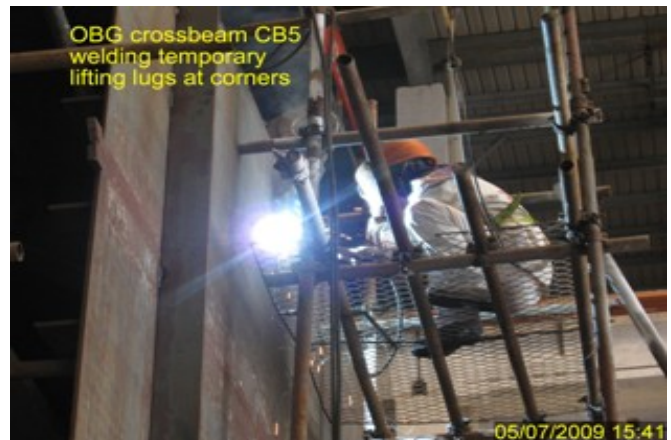
Unless otherwise noted, all work observed on this date appeared to be in general compliance with the applicable contract documents.
